iPhone 6s Plus Teardown

Torn down on September 25, 2015 in Melbourne, Australia.

Written By: Andrew Optimus Goldberg

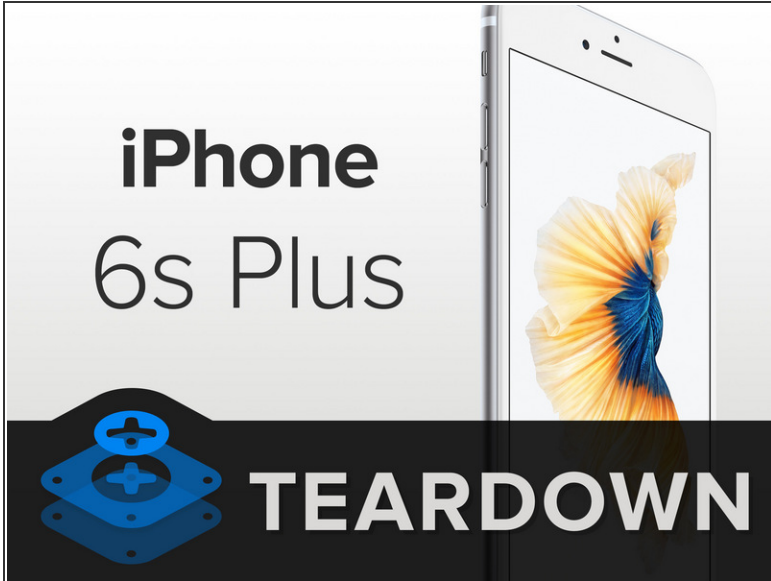
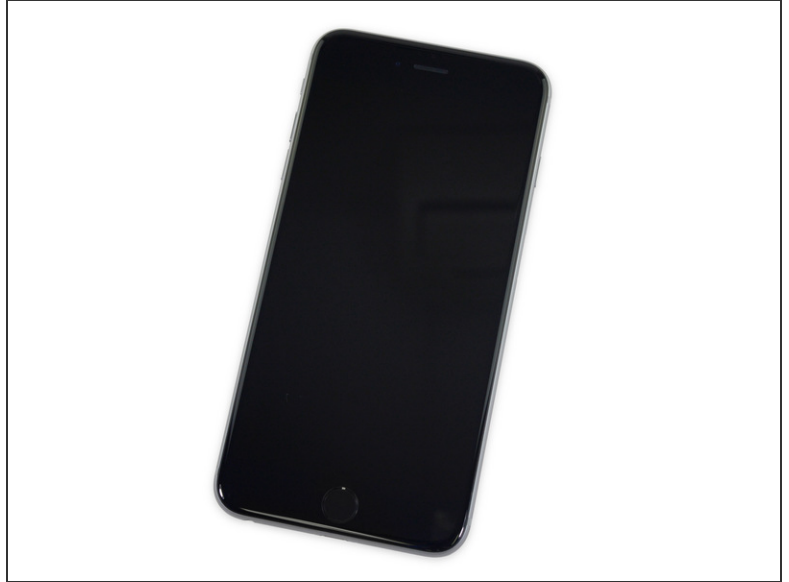
Step 1 — iPhone 6s Plus Teardown

- Before we put this bad boy under the knife spudger, we have to ask: "Hey Siri, what's under the hood?":
 - Apple A9 processor with embedded M9 motion coprocessor
 - 16, 64, or 128 GB of storage
 - 5.5-inch 1920 × 1080 pixels (401 ppi) Retina HD display with 3D Touch
 - 12 MP iSight camera supporting 4K video recording with 1.22μ pixels, and a 5 MP FaceTime HD camera
 - 7000 Series aluminum enclosure and Ion-X Glass
 - 802.11a/b/g/n/ac Wi-Fi with MIMO + Bluetooth 4.2 + NFC + 23-band LTE
 - Taptic Engine

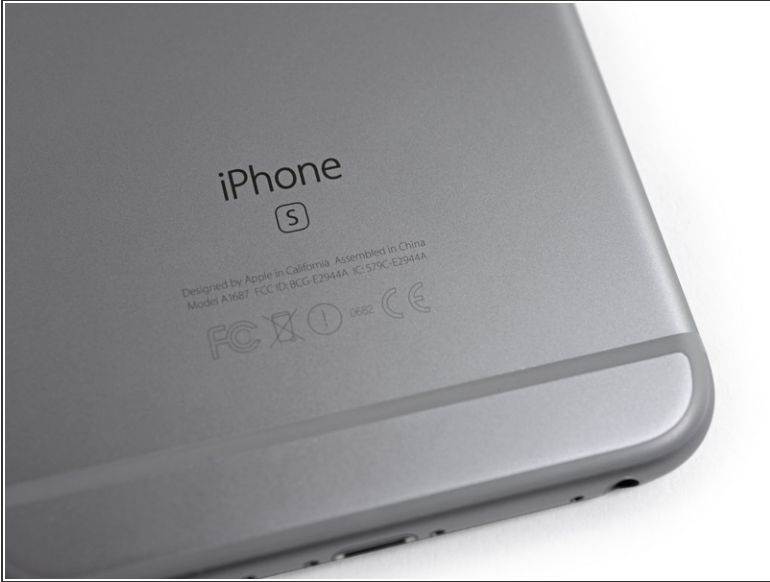
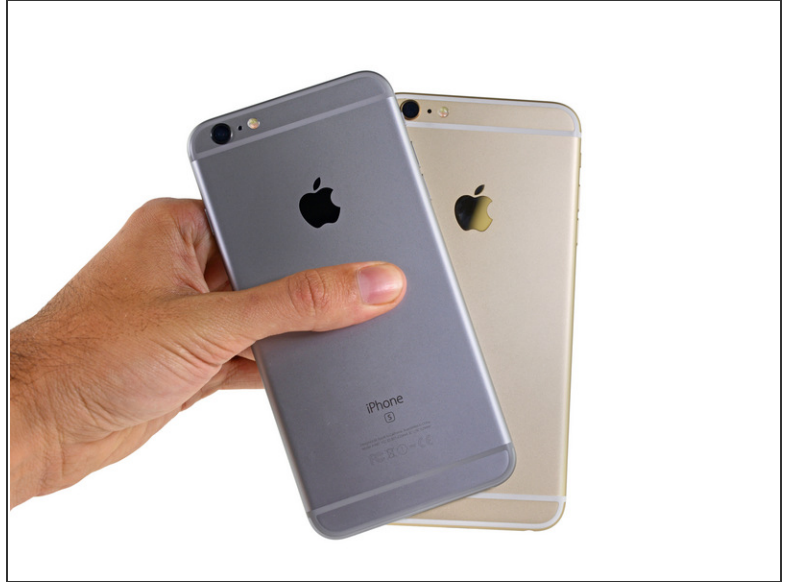
Step 2

- The 6s Plus stops by for a closeup and gives us a better view of that custom [7000 series aluminum alloy](#) and flaunts a new model number: A1687
- [Early analysis](#) of this new alloy breaks it down to around 91.17% aluminum, 0.08% iron, 7.64% zinc, and 0.106% tungsten.
 - The higher zinc content should provide a significant increase in tensile strength (and manufacturing cost) from the [6063 aluminum alloy](#) in the iPhone 6.
- That little "[S](#)" looks out of place on the new iPhone's large outer casing—but how else will you show your friends that you buy a new phone [every year](#)?
- Really though, Apple's new push to encourage early upgrades is a low blow to the environment. As recyclable as Apple claims their devices are, a shorter product lifetime means increased [carbon dioxide emissions](#) and more e-waste.

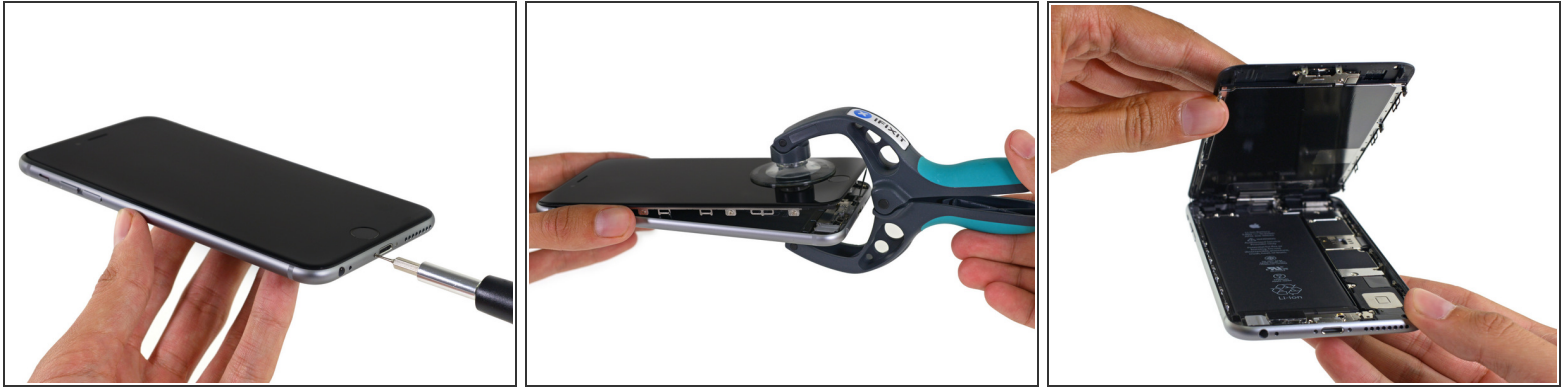
Step 4

- Having just torn down the 6s, we know exactly where to start with the Plus.
- Our teardown engineer busts open the phone in two seconds flat—one second for each screw, all caution thrown to the wind. (Just kidding, he's actually very careful and takes his time. This is the only 6s Plus we've got.)
- Just like its [smaller sibling](#), the 6s Plus features an adhesive strip along the perimeter of the display assembly. Lucky for us, it doesn't stand a chance against the [iSclack](#).
- With the Pentalobe screws out and display adhesive defeated, we're in!

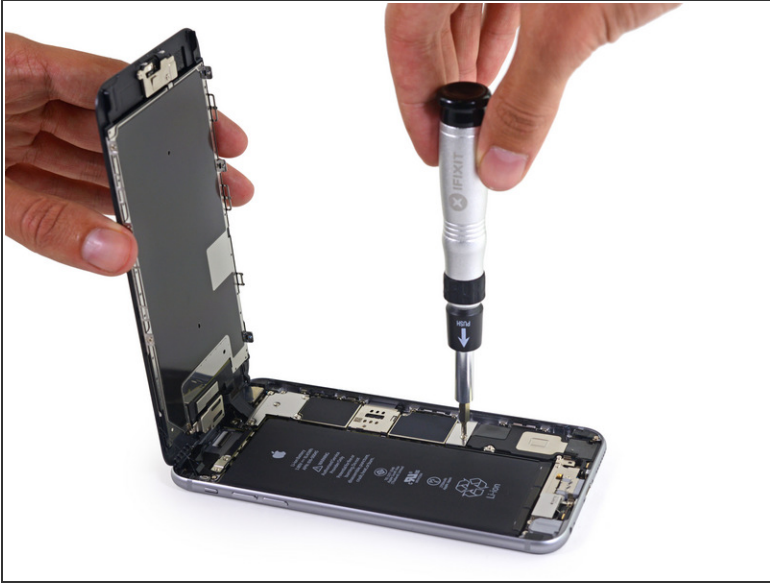
Step 5

- The battery connector is the first priority on our path to teardown glory.
- As with the [6s](#), we are pleased to discover that all of the internal screws in the 6s Plus are Phillips screws. The fewer [Pentalobe screws](#) there are, the happier we are.

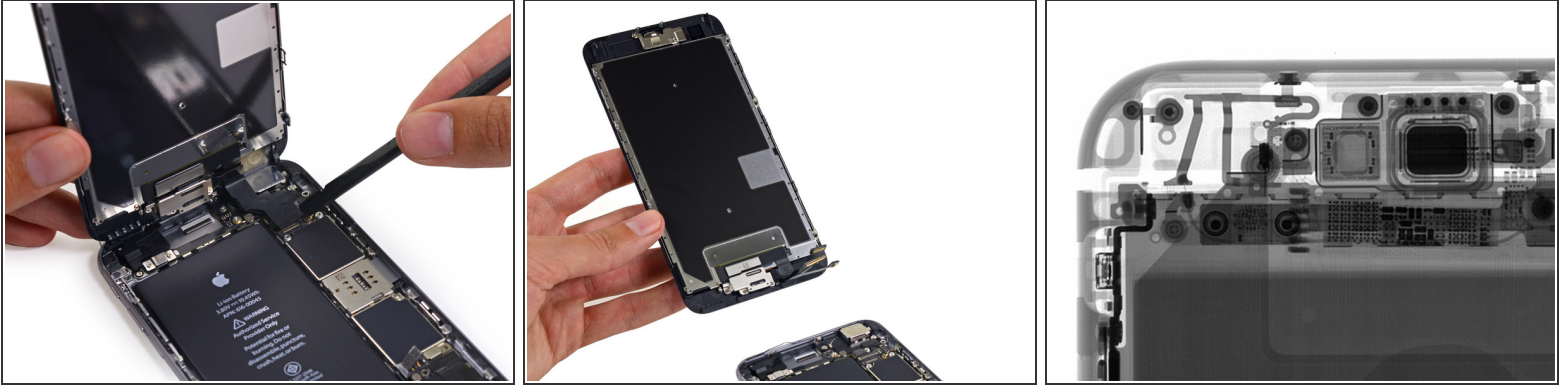
Step 6

- With three [flicks](#) of our spudger, we quickly disconnect and remove the display assembly.
- Before we move on, we toss it on the scale. We note that the display assembly on the 6s Plus weighs in at 80 g—while on last year's 6 Plus, it weighed a measly 60 g.
 - This astonishing 33% increase in weight is all because of Apple's new 3D Touch technology. That's some heavy stuff.
- A quick blast of X-rays reveals the presence of some new silicon piggybacking onto the display —[just like we found on the 6s.](#)

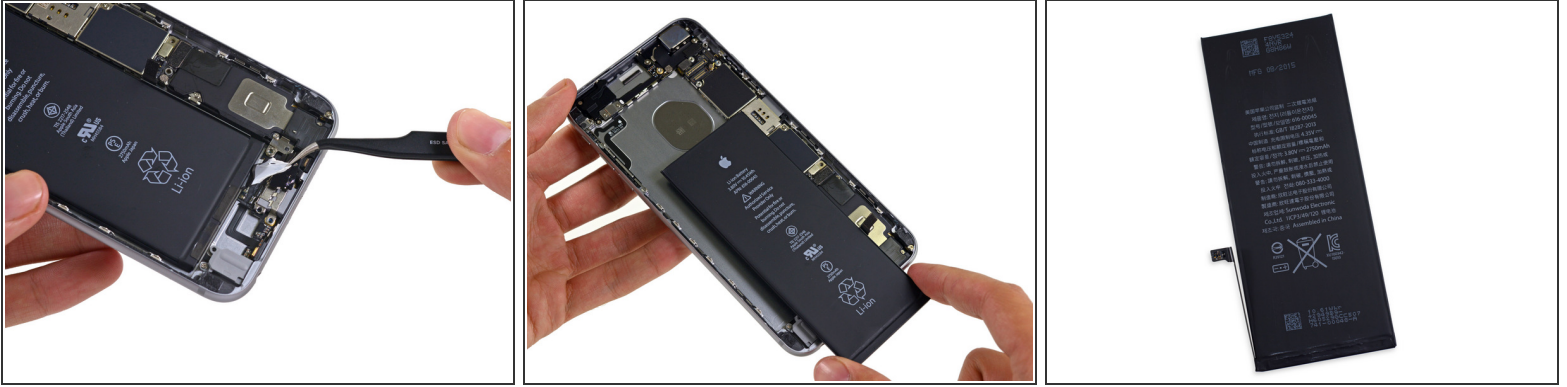
Step 9

- Moving on to the battery, we're greeted with a few familiar friends—adhesive pull tabs.
 - Never stop being awesome, adhesive pull tabs. *Never.*
- Much like the 6 Plus before it, removing the battery is as easy as pulling 3 tabs. Well, as long as you pull them *exactly* right.
- The battery capacity sits at 2750 mAh (10.45 Wh); a modest 165 mAh downgrade compared to last year's 6 Plus.
- ❗ Despite the downgrade, Apple claims battery life will be comparable to that of the 6 Plus—that is, 14 hours of 3G talk time, approximately 10 hours of internet use, or up to 10 days on standby.

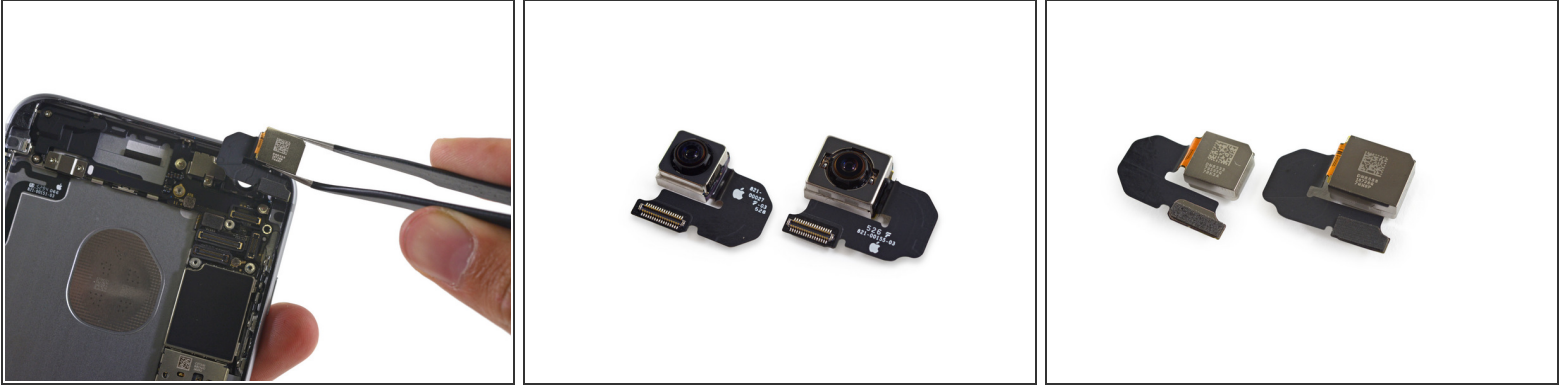
Step 10

- For the second time today, we pluck the 12 MP iSight camera from its cavity for a closer look.
- At first glance, the iSight camera in the 6s Plus is fairly similar to the one found in the 6s. When the two cameras are laid out side-by-side though, the additional heft of the [optical image stabilization](#) hardware in the iPhone 6s Plus camera becomes readily apparent.

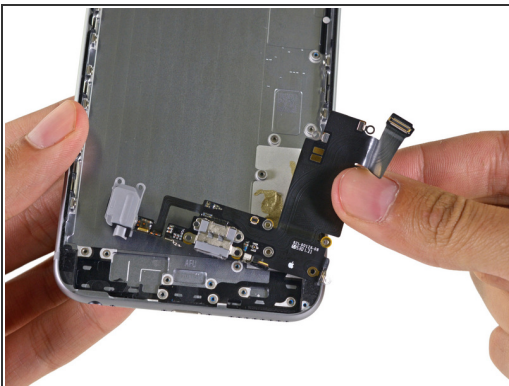
Step 18

- Alas, the last piece of the teardown puzzle—the Lightning connector assembly.
- This time around, the Lightning connector assembly brings us everything we've seen [before](#) and *then some*, with the addition of a second microphone.
- ⓘ This assembly is convenient as a space-saving measure, but it has a nasty side effect—repairing a single damaged Lightning port or headphone jack requires replacing the *entire* assembly.
